Enhancing Oil Palm FFB Yields by Water Management: Sumber Tani Agung Resources' Experiences

Sundian Nadaraj, Eriston Hutabarat and Pupathy Uthrapathy Thandapani

Sumber Tani Agung Resources Tbk,
Jl. Pangeran Diponegoro No. 51, Medan, Indonesia.

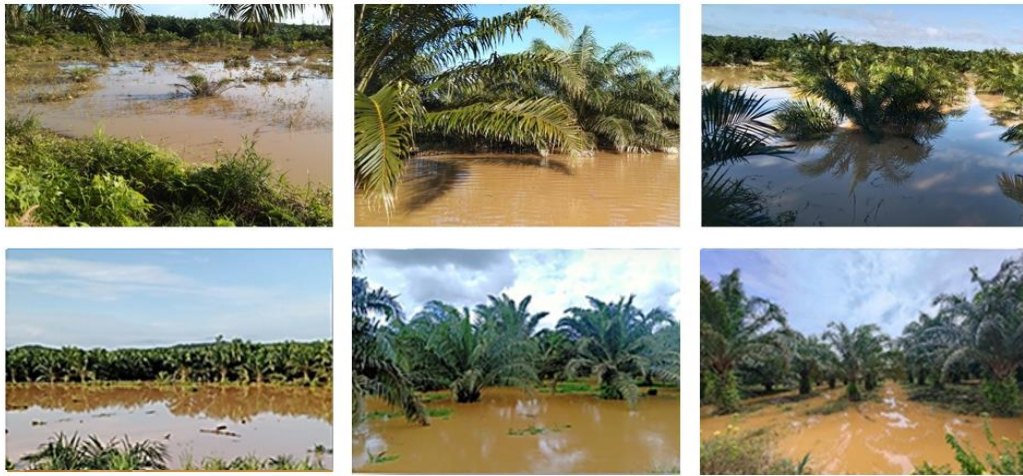
Figure 2: Conditions of rivers as well as surroundings of fields during heavy rainfall season within study area

There is a huge tendency for areas in both estates exposed to the problems of flooding incidences as (i) Annual rainfall of this region would fall within 3500 mm-4000 mm, (ii) Out of this, almost 30-40% of the total annual rainfall is recorded in the period of October-December (iii) Furthermore, during the same period, high rainwater from nearby Forest Reserve of Bengkayang had resulted high water volume in the streams/ rivers running across both estates. Factors from (i) to (iii) generally would cause overflow of water from both banks which usually became a stagnant in the nearby fields (**Figure 2**).

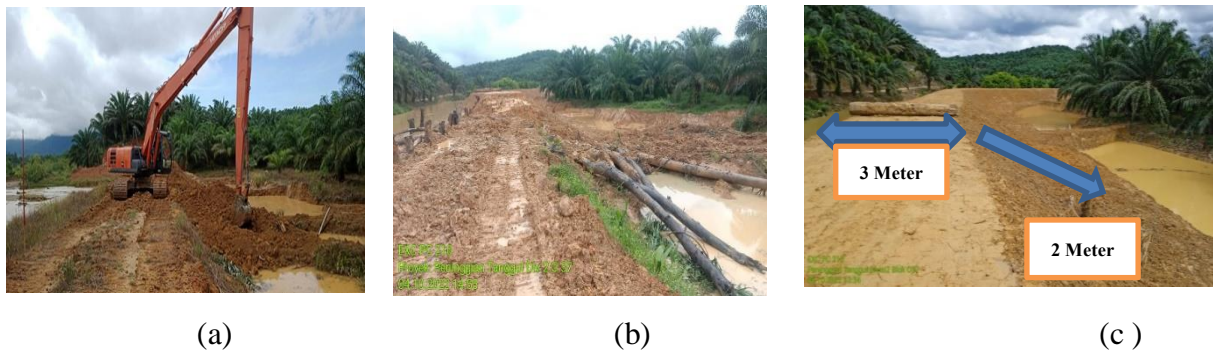
Figure 5: Heightening of banks along the rivers (a) works by excavators, (b) embankment in progress and (c) completed embankment with 3 meter width on the top surface

Embankment project was carried out phase by phase in both Seret Ayon and Lembah Bawang estates since 2017 and 2019 respectively. A total of 38.39 km along the rivers of Sebangkau, Setangau and Sepang in Seret Ayon Estate while for Lembah Bawang Estate, a total of 8.9 km along the Sepang and Karangan rivers (**Figure 5**).

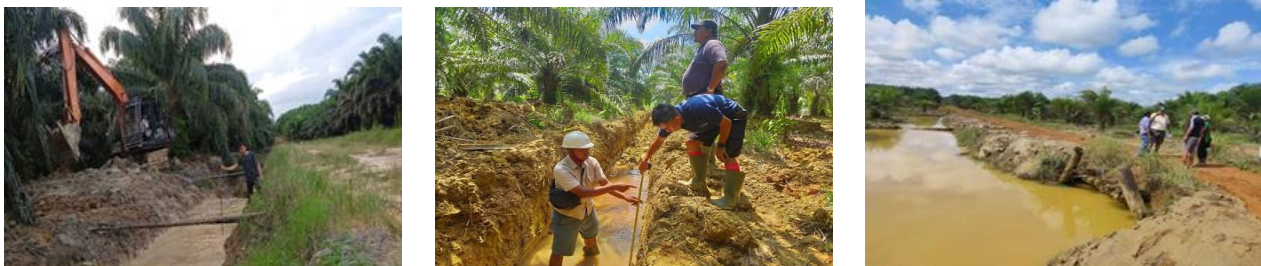
Figure 6: Monitoring fields during the embankment project

Efforts should be taken to ensure the stability of riverbanks together with embankment. After a heavy pour, a patrol should carry out monitoring and checking of any weakness in embankment area such as sudden collapse of riverbank (due to more sandy type of soil texture) and /or overflow of river after for an extended period of rainfall. Estate personnel must continue monitoring the riverbanks throughout the year, be wet or dry seasons.

In all situations, for an embankment system to be effective, constant supervision and good maintenance of the water-control structures such as monitoring watergates, flap-gates, weeds in the drains and smooth removal of excess water after raining should be carried out (**Figure 6**).

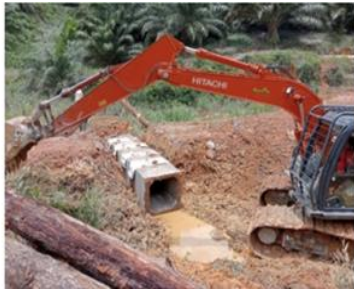
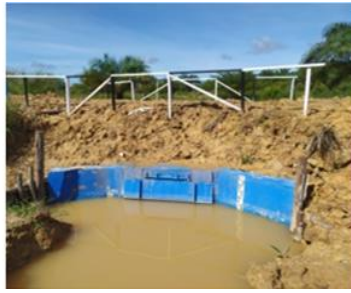
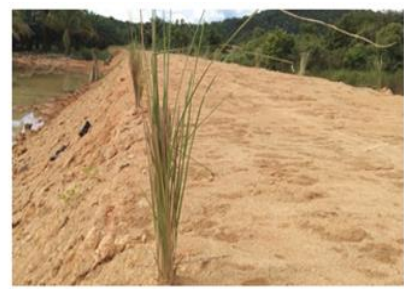
(a)

(b)

(c)

Figure 7: Maintenance and repairing works (a) fixing culvert, (b) flap-gate maintenance and (c) planting of Vetiver grass on recently embankment area, so not easily eroded if the water rises.

Maintenance/desilting of drains are very important because it will greatly affect the volume and smoothness of the outgoing water to main outlets. Repairing of main drains, collection drains, field drains or outlet drains, must be attended immediately to prevent any breakdown of embanked riverbanks. Immediate attention should be given to any water gates or flap-gates requires repairs or fixings (**Figure 7 (a & b)**). Vetiver grasses were also established on riverbanks (**Figure 7 (c)**). Planting of such Vetiver grass would help to reduce soil erosion and thus it is envisaged that lifespan of embankment be extended.

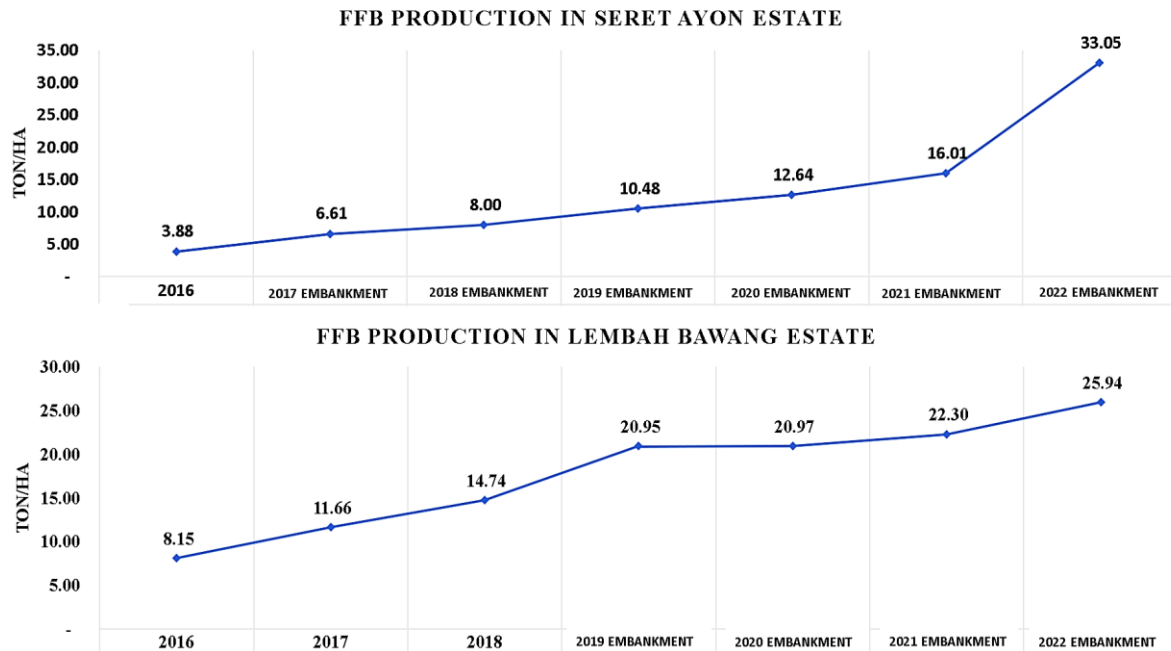
Figure 8: FFB yield improvement after embankment project in Seret Ayon and Lembah Bawang estates

As a result of embankment project, total areas improved by 2022 are 413.48 ha and 152.97 ha in Seret Ayon and Lembah Bawang estates respectively. In Seret Ayon Estate, with the construction and elevation of the embankment, FFB yield production has increased from 10.48 tons/ha in 2019 to 33.05 tons/ha in 2022 (**Figure 8**). This representing an increment of 22.57 tons/ha or 315%. If converted to the current price of palm oil in the West Kalimantan region of IDR 2,370/Kg, the profit due to embankment project is IDR 53,490,900/Ha (22,570 Kg/Ha x IDR 2,370/Kg). As approximately 413.48 ha of land was improved from the adverse impacts of frequent floodings, a total of IDR 22,117,417,332 was realized in 2022 (IDR 53,490,900/Ha x 413.48 Ha).

Similarly, there was an increment in FFB production in Lembah Bawang Estate from 11.66 tons/ha in 2017 to 25.94 tons/ha in 2022, representing an increase of 14.28 Tons/ha or 223%. With the palm oil price of IDR 2,370/Kg in the West Kalimantan region, the profit from the increased FFB production is IDR 33,843,600/Ha (14,280 Kg/Ha x IDR 2,370/Kg). As such, for an improved area from frequent flooding incidences of 152.97 ha in Lembah Bawang Estate, IDR 5,177,055,492 worth of FFB production is realised in 2022 (IDR 33,843,600/Ha x 152.97 Ha). Assuming the conversion rate of 1 USD = IDR 15,000, an additional income due to embankment project for Seret Ayon and Lembah Bawang estate is equivalent to USD 1,474,494 and USD 345,137 respectively.

Basically, the improvement in field conditions, drains and roads had resulted in the betterment of FFB evacuation and transportation of FFB to mills. As a result, there is a major FFB yield improvement realised in 2022 in both estates. As shown in **Figure 8**, throughout the years of 2016-2021, yields in Lembah Bawang Estate was higher than those from Seret Ayon Estate for the same period. However, in 2022, there was a significantly higher FFB yield production in Seret Ayon Estate (33.05 tons/ha/yr) as compared to those from Lembah Bawang Estate (25.94 tons/ha/year). This might have attributed due to earlier embankment project in 2017 for Seret Ayon Estate as compared to Lembah Bawang Estate, where an embankment project was initiated only in 2019. Furthermore, total areas improved due to embankment project in Seret Ayon Estate was approximately 413.48 ha as compared to the 152.97 ha of improvement areas in Lembah Bawang Estate. As such, the FFB yield increment in Seret Ayon Estate was better than Lembah Bawang Estate. **Figure 9** shows the improvement on the ground *before* and *after* the embankment of embankment project in Seret Ayon and Lembah Bawang estates in STAR.

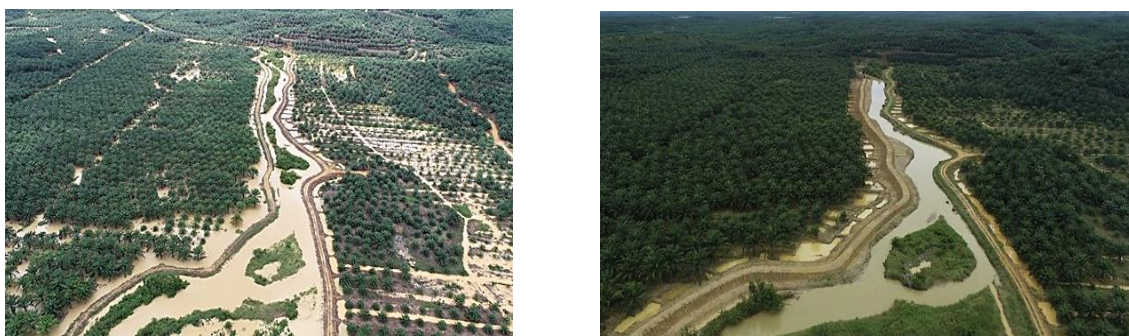
Figure 9: Field condition and appearance of palm health *before* and *after* embankment project in the same areas in Seret Ayon and Lembah Bawang estates, near Sambas, Indonesia
